DEPARTMENT OF TRANSPORTATION**DIVISION OF ENGINEERING SERVICES**

Quality Assurance and Source Inspection

Contract #: 04-0120F4Cty: SF/ALA Rte: 80 PM: 13.2/13.9File #: 69.28**WELDING INSPECTION REPORT****Resident Engineer:**Pursell, Gary**Address:** 333 Burma Road**City:** Oakland, CA 94607**Report No:** WIR-009587**Date Inspected:** 05-Oct-2009**Project Name:** SAS Superstructure**OSM Arrival Time:** 700**Prime Contractor:** American Bridge/Fluor Enterprises, a JV**OSM Departure Time:** 1900**Contractor:** Zhenhua Port Machinery Company, Ltd (ZPMC), Changxing Island **Location:** Shanghai, China**CWI Name:** Chen Xi**CWI Present:** Yes No**Inspected CWI report:** Yes No N/A**Rod Oven in Use:** Yes No N/A**Electrode to specification:** Yes No N/A**Weld Procedures Followed:** Yes No N/A**Qualified Welders:** Yes No N/A**Verified Joint Fit-up:** Yes No N/A**Approved Drawings:** Yes No N/A**Approved WPS:** Yes No N/A**Delayed / Cancelled:** Yes No N/A**Bridge No:** 34-0006**Component:** OBG Crossbeams**Summary of Items Observed:**

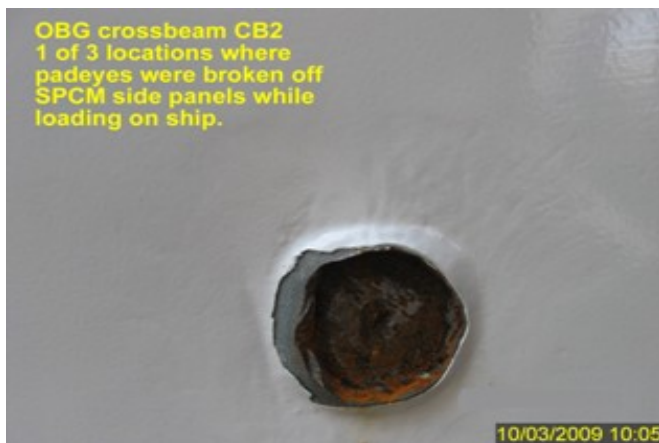
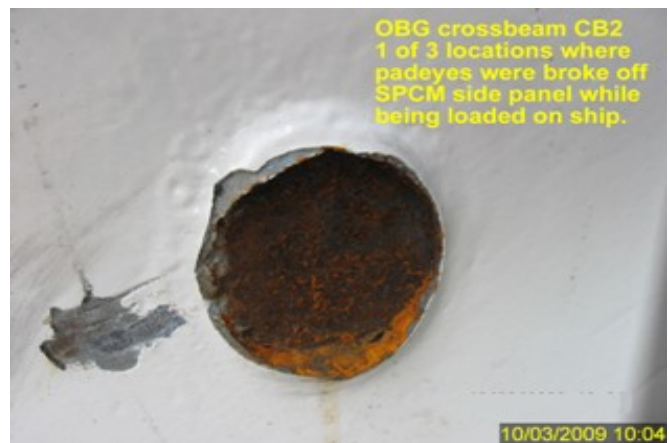
Caltrans QA coatings inspector Mr. James Lumley was present when this crossbeam was loaded onto the ship. Mr. Lumley brought it to this QAs attention that three (3) padeyes appear to have been broken off of the SPCM side panels of this crossbeam while being loaded. Mr. Lumley shared several photographs of this issue with this QA. This crossbeam was loaded onto the ship on 10/03/09. This QA is unable to gain access to this crossbeam at this time in order to confirm the locations and to visually inspect the affected areas. Attached are two of Mr. Lumleys photos of two of these locations.

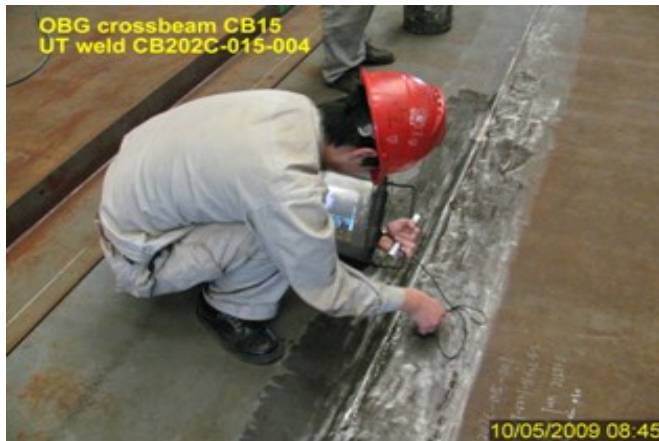
This QA observed the contractors Quality Control (QC) Ultrasonic Testing (UT) technician testing Fracture Critical Welds (FCW) identified as CB202C-015-001 and 004. The technician did not appear to be scanning the welds in a manner compliant with the specified procedures in AWS D1.5 2002. The technician appeared to be using scanning pattern B and C only. AWS D1.5 2002 section 6.19.6.2 states "All butt joint welds shall be tested from each side of the weld axis. Corner and T-joint welds shall be primarily tested from one side of the weld axis only. All welds shall be tested using the applicable scanning pattern or patterns shown in Figure 6.7 as necessary to detect both longitudinal and transverse flaws. It is intended that, as a minimum, all welds be tested by passing sound through the entire volume of the weld and the HAZ in two crossing directions, wherever practical". Figure 6.7 indicates that scanning patterns A, B, C and E are required for this type of joint. This QA notified ZPMC QA identified as Mr. Zhang Wei and ABF representative identified as Mr. Mike Williams of the above mentioned issue and that an incident report would be generated. A video of this technician performing the testing can be viewed on the Caltrans server under "Team OBG" file name "UT Video_10-05-09". This QA noted that the technician marked three areas on weld joint CB202C-015-001 suspected to be weld cap indications, to be repaired by grinding and re-tested.
